U. S. Army Rotary-Wing Emergency Egress Study

May 1995

U.S. Army Aeromedical Research Laboratory
Fort Rucker, Alabama 36362-0577

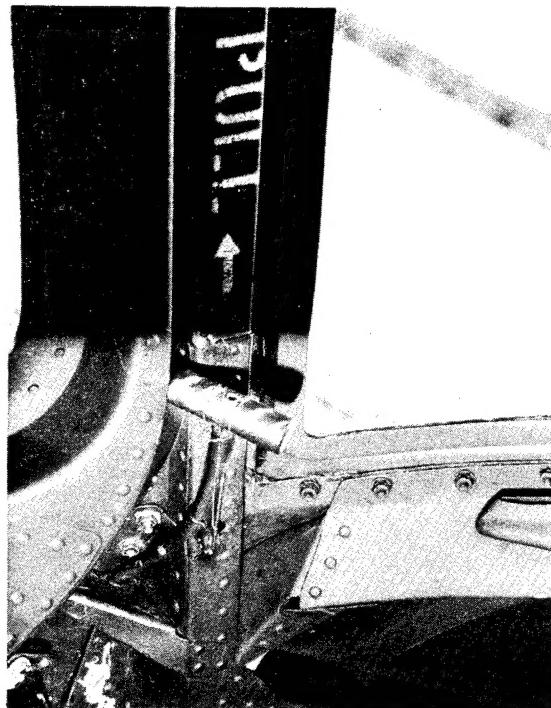
Figure 2. UH-1 cockpit emergency egress handles.

Cockpit --- Emergency exit release handles are located on the front of the cockpit doors, directly above the upper hinge. The T-shaped handles are yellow and black striped. Operating instructions are readable easily and located on the front door frame above the T-handle, as

shown in Figures 1 and 2. Pulling the T-handle upwards pulls a cable which releases pins through the door hinges. Once the pins come out, the hinge separates, and the cockpit door is free to fall away. Force required to break the safety and disengage the pins is 25-30 lbs. The door then will fall off by itself or with slight pressure upon it. The opening then is the size of the door frame minus the restric-

tions of the cyclic, armor plate and the collective. The operator's manual displays the emergency exit release handles, but does not have them labeled as seen in the Appendix, Figure 3. Emergency procedures in chapter 9 of the operator's manual are simple and adequate. The cockpit

doors jettison easily and quickly. The armor protection panel on the seat is difficult to slide rearward and takes both hands to operate. With the panel forward, it is difficult to egress and this is the procedure's weak link.

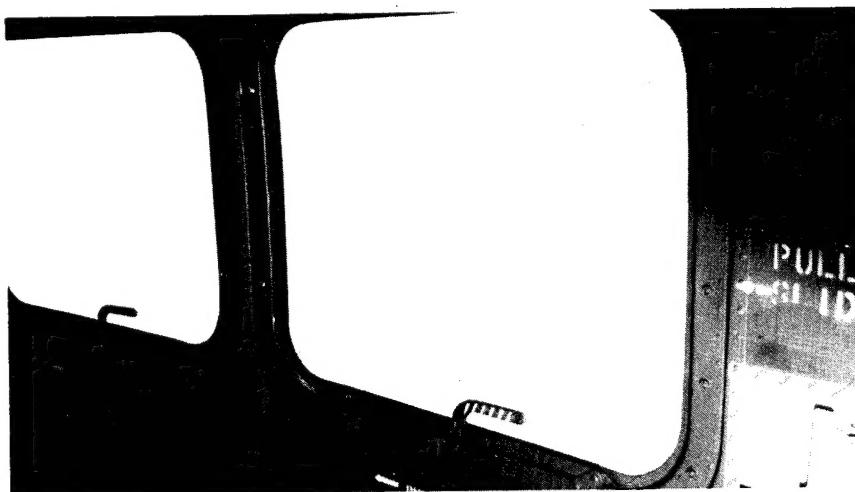
Figure 5. UH-1 cabin emergency egress handles.

Cabin --- The cabin door window emergency release handles are located at the bottom center of each window. The handles are yellow and black striped. Operating instructions clearly are visible as can be seen in Figures 4 and 5. Lifting up on the handle with 20-25 lbs. of force

retracts stops along the bottom of the window. The bottom of the window then can be pulled inward with minimal force. The top of the window falls free of the frame and the entire window drops into the cabin. It is important to note the window can not be pushed outward, it must pulled inside, and is so noted in the instructions. Then occupants are unrestrained from exiting the aircraft. The operator's manual displays a labeled picture of the exits and handles as seen in the Appendix, Figure 6. Emergency procedures in chapter 9 are simple and adequate.

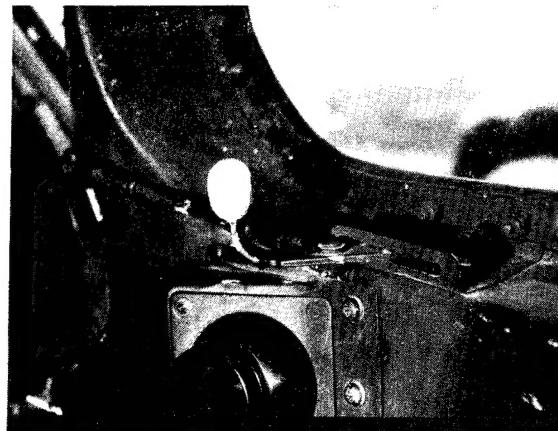
Figure 7. UH-60 cockpit area.

Cockpit --- Emergency release handles are located on the inside frame of each cockpit door. They allow the cockpit doors to be jettisoned in case of an emergency. The handles are yellow and are

surrounded with ample instructions as shown in Figures 7 through 9. Pulling the emergency handle with 40-45 lbs. of force turns a cam inside the door allowing the door to be separated from the hinge at the mounting points. The operator's manual emergency procedure states the door then may be jettisoned by kicking the lower forward corner. This procedure works; however, on the doors tested, it required *substantial* force to dislodge the door from the hinge. Once the connection is broken, the door falls away from the aircraft. As with the UH-1, the egress is hampered substantially if the protective armor plating has been moved forward. However, unlike the UH-1, the plating on the UH-60 can be moved rearward with only

one hand. The weak link of this procedure is the process of kicking the door away from the hinge.

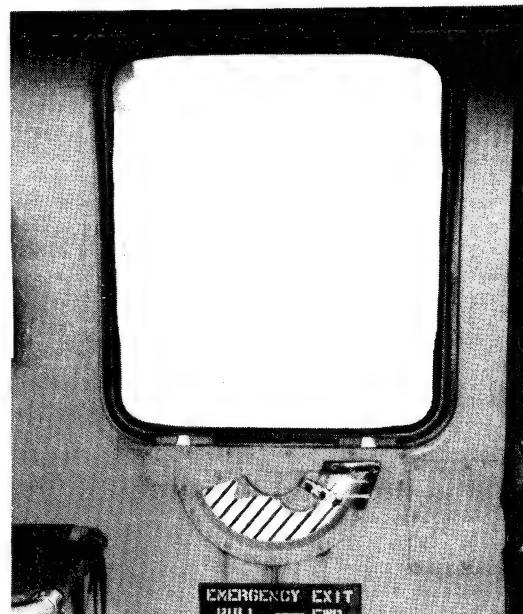
Figure 10. UH-60 cabin area.

Cabin --- The egress from the cabin area of a UH-60 is unique and poses no

physical difficulties, but it could be confusing under certain circumstances. First under normal egress procedures, passengers seated in the aft area are unable to reach the handle of the cabin door when the system of seating four across the center is used. The doors must be opened by someone sitting in the forward area or from the outside. Second, there is only one cabin door window jettison handle on each cabin door, and they are in different locations on each side. The handles are located under the front window on the left cabin door and under the rear handle on the right side door as shown in Figures 10 and 11. In the Appendix, the cabin's emergency exits can be seen in Figure 12. The locations make it very difficult for passengers in the front area to operate the right side emergency exit, and for passengers in the rear area to jettison the cabin windows on the left side. The direction of handle pull on each side also is different. On the left side the handle is pulled aft and the handle on the right is pulled forward as explained under emergency exits in the operator's manual. On the positive

side of the egress procedure, it takes only approximately 10 lbs. of force to operate the handles and then the windows easily are pushed outward. Pulling the handle releases both the front and the rear cabin door windows on that side.

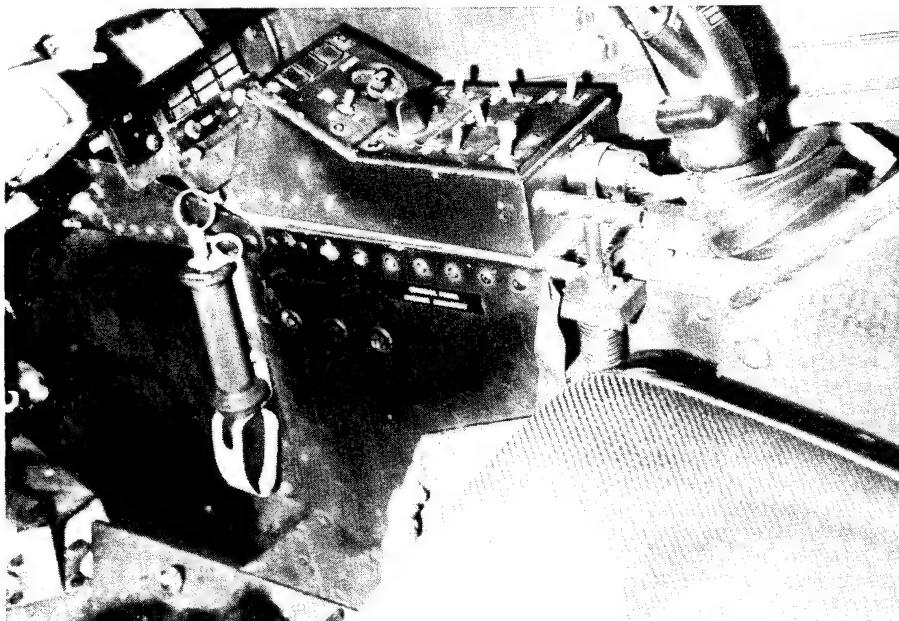
Figure 13. AH-1 copilot/gunner cockpit area.

Cockpit only --- The Cobra contains a canopy jettison system that can be operated from either the pilot's rear seat or the copilot/gunner's, (CPG) front seat. The arming/firing mechanisms are located near the instrument panel and have operating instructions on them as shown in Figures 13 through 17. These firing mechanisms are operated by turning the handle 90 degrees counterclockwise with a torque of 6-12 inch-pounds. This maneuver arms

the assembly. The operator then pulls the handle with 20-35 lbs. of tension, firing the primer and causing the cutting assembly to be detonated. The process is completed by the detonation cord, that burns around the periphery of all the side panels, sever-

ing them from the fuselage. This system is explained in chapter 2, section II of the operator's manual, but there are no emergency procedure steps outlined in chapter 9. Once the canopy is jettisoned, there is a clear access area for the pilots to egress.

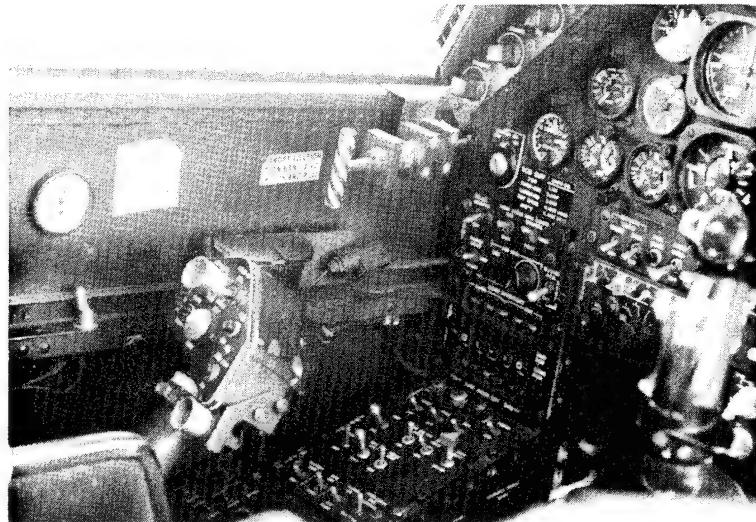
Cockpit only --- The Apache also has a canopy jettison system that expels the four acrylic panels on the sides of the pilot and CPG stations. The Apache however, has three canopy jettison handles. One is on the upper left corner of the pilot's instrument panel. A second is at the upper left corner of the CPG panel. And the third is the external ground crew handle located on the front of the aircraft, under a quick-release panel directly forward of the CPG's windshield as shown in Figures 18 through 23. Like the Cobra, the Apache system is based on an arming/firing handle, a primer/initiator, and a

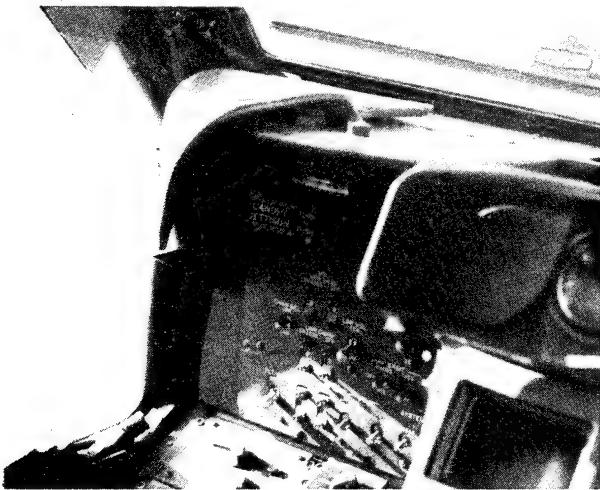
Figure 18. AH-64 copilot/gunner cockpit area.

detonation cord around the periphery of the side panels. The operating instructions again are directly on the jettison handles. The system is armed by rotating the canopy jettison handle 90 degrees left or right, which then uncovers the word ARMED on both sides of the handle. The system then is activated by pushing the jettison handle in, detonating the primer/initiator within the handle. The system is explained very well in chapter 2 of the operator's manual. The emergency egress procedures are in chapter 9.

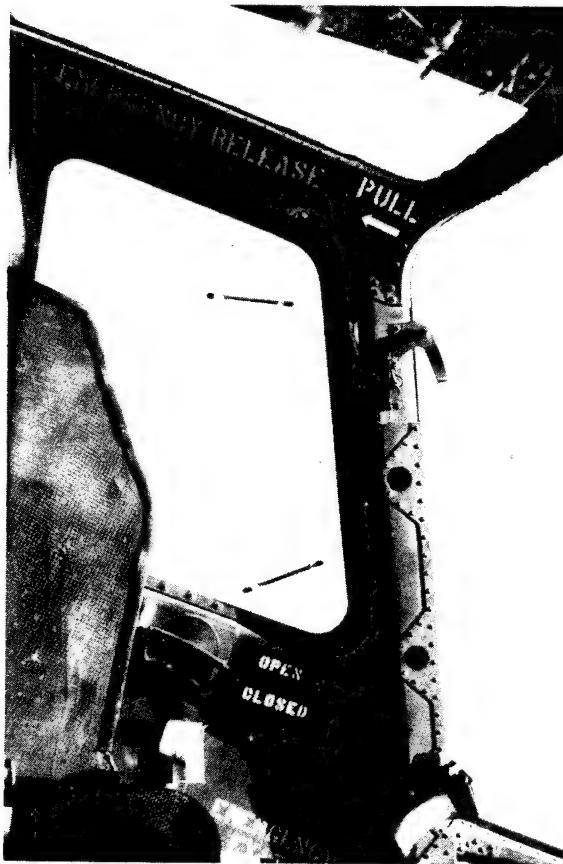
Figure 24. OH-58 cockpit area.

Cockpit --- The cockpit door emergency jettison handles are located on the inside of the door frames just above the upper hinges. The yellow handles are di-

rectly above the emergency exit labels on the door frame as shown in Figures 24 through 26. Pulling aft on the handle with a force of 15-25 lbs. pulls pins on both hinges, allows the hinges to separate, and internal springs then push the door out and away from the aircraft. The handle was difficult to pull aft if there was pressure on the handle towards the center of the cockpit while pulling. We found the end of a mounting bolt restricted the rotation of this lever. This easily was compensated for by applying slight outward pressure on the handle while pulling aft. The armor plating opens easily and quickly

with the outside hand and is not an obstacle while exiting the aircraft. However, if for some reason, i.e., hard landing, the armor should become stuck, the egress area would be reduced substantially. The operator's manual has good figures of the

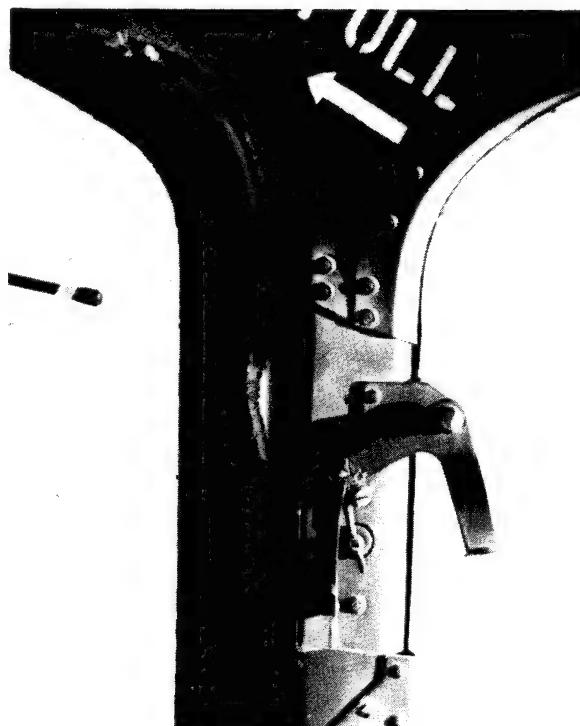
Figure 25. OH-58 cockpit emergency egress handles.

emergency jettison handles and has concise and simple operating instructions in chapter 9. Also, it is important to note in this aircraft the cockpit emergency handles are in a good location to be utilized as hand rests. The operator's manual has a warning in chapter 2 that this may result in inadvertent jettisoning of cockpit doors.

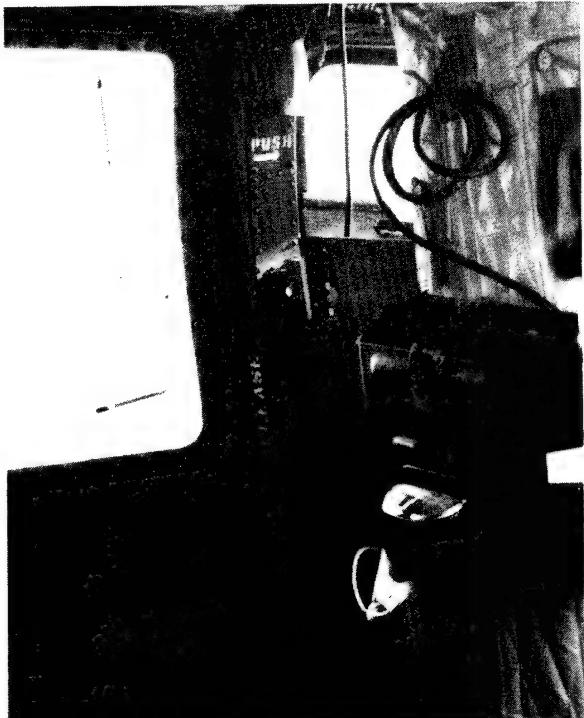
Figure 26. OH-58 cabin area.

Cabin --- The cabin emergency jettison handles are located on the aircraft frame between the cockpit and cabin doors. The handles are yellow and black striped with instructions on the frame immediately below them as shown in Figures 26 through 28. They operate in a similar fashion and equally as effectively as the cockpit jettison system. The differences is that the cabin handle must be pushed forward and the force required is 25-30 lbs. The door then is easily popped off with the assistance of springs, opening a large egress area. It should be pointed out that if the passenger in the rear is restricted by their inertial reel seat restraint, they may have difficulty reaching the emergency handle because of the distance.

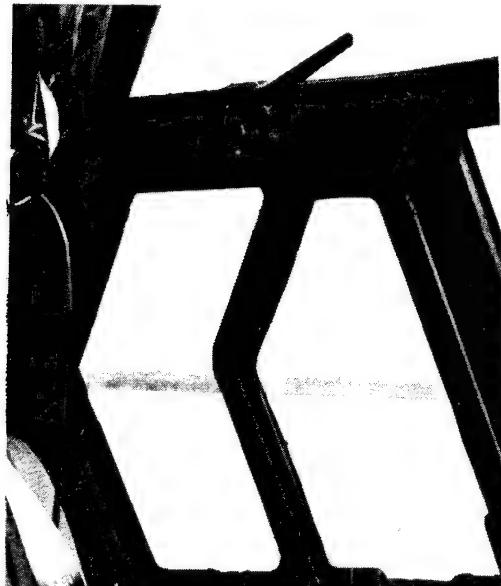
Figure 29. CH-47 cockpit area.

Cockpit --- Inside handles for the cockpit door emergency exit are located directly above the cockpit doors. The handles are yellow and black striped with operating instructions on them as shown in Figures 29 and 30. The handles either can be pushed up or pulled down to disengage the entire door from the frame. The door then falls out, top first. There are no warnings in the operator's manual about using this handle as a hand rest, but care

must be taken to prevent accidental jettisoning. The system also may be activated by outside emergency handles located directly below and aft of the cockpit doors. To operate, the handle first must be extended from the aircraft, then turned

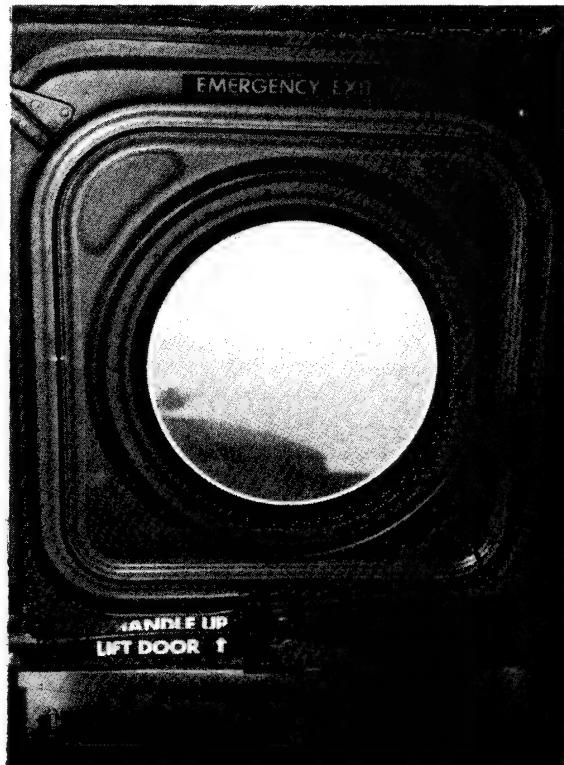
Figure 32. CH-47 cabin area emergency egress window straps.

emergency exit on the ramp shell, the shell itself, or exiting through the cargo hook viewing hatch. The windows are jettisoned by pulling a yellow strap hanging from each window as shown in Figure 32. The strap is connected to a seal that runs completely around the window. Pulling the strap away breaks the entire seal and the window then can be pushed out. In addition to the window, a square panel around the window comes out with the front exits on either side, and the exit located on the ramp shell. Adequate instructions for operating these emergency exits are located near the exits and in chapter 9 of the operator's manual as shown in Figures 34 and 35.

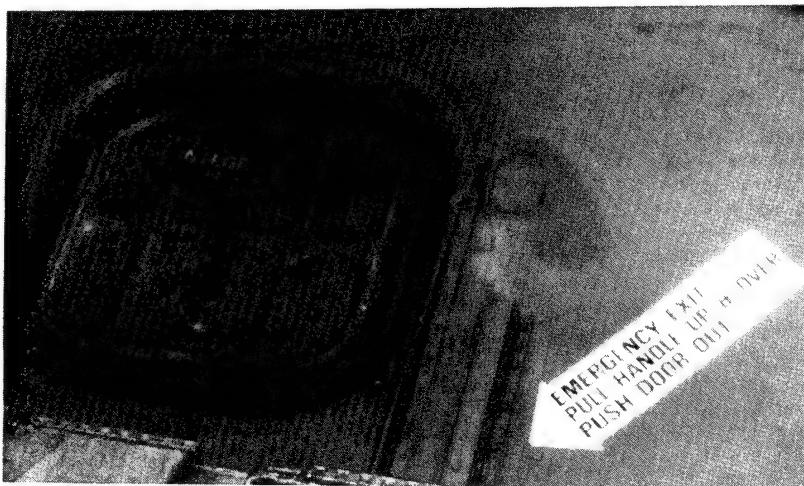
Figure 31. CH-47 cabin area emergency egress door strap.

while pushing in the trigger button. The instructions for this procedure are painted on the side of the aircraft. When this technique is used, the bottom of the door comes out first. The person operating the exterior handle should be aware of, and avoid the falling door. The force required to turn either handle is between 35 and 40 lbs. With the door off, there is ample room to exit the aircraft. The operator's manual contains ample pictures of the emergency escapes in chapter 9 as shown in Figure 31.
